Technical BULLETIN

2002 SXV70G/ERG (“SXViper”) Overheat Warning Indicator

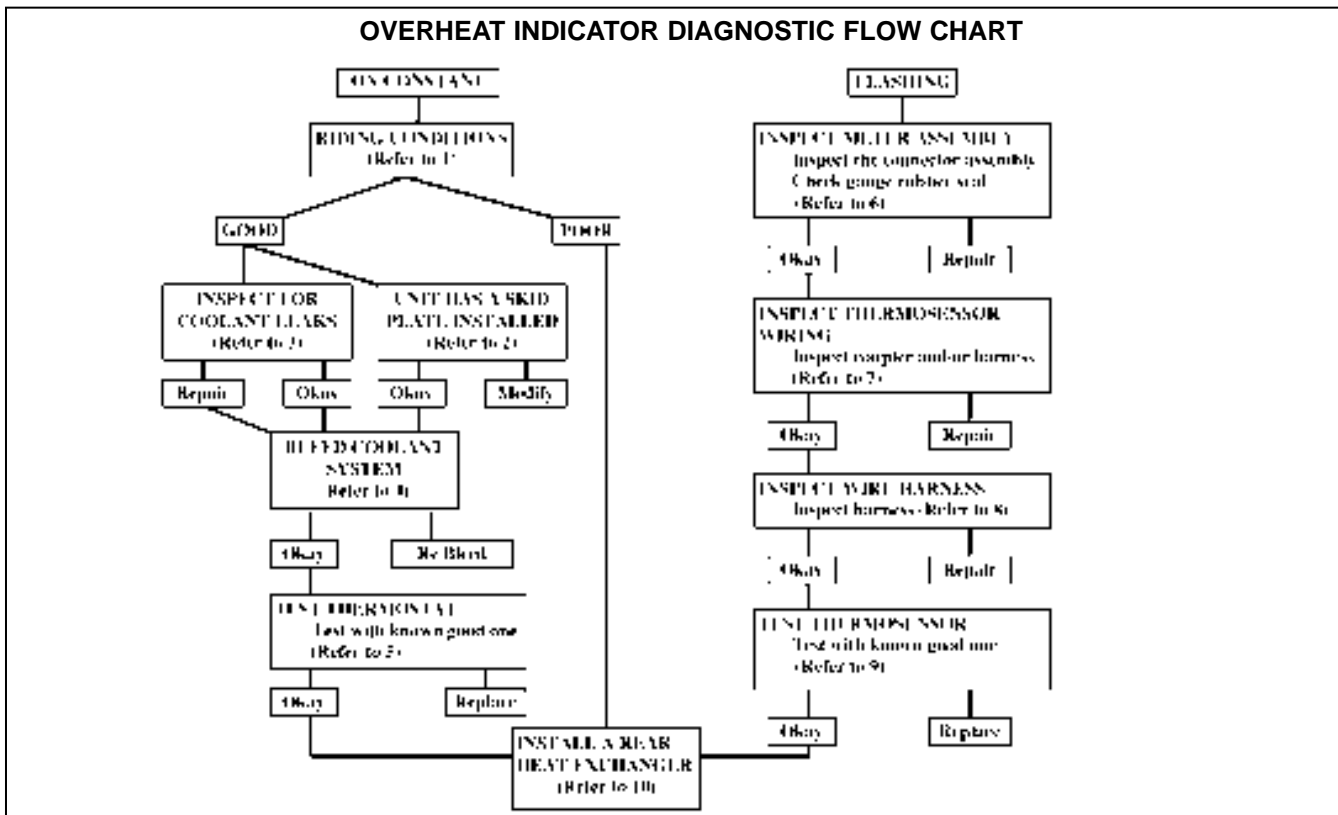
Use the following diagnostic flow chart and the accompanying steps it references to find and correct the problem.
