Technical BULLETIN

2002 SXV70G/ERG (“SXViper”) Overheat Warning Indicator

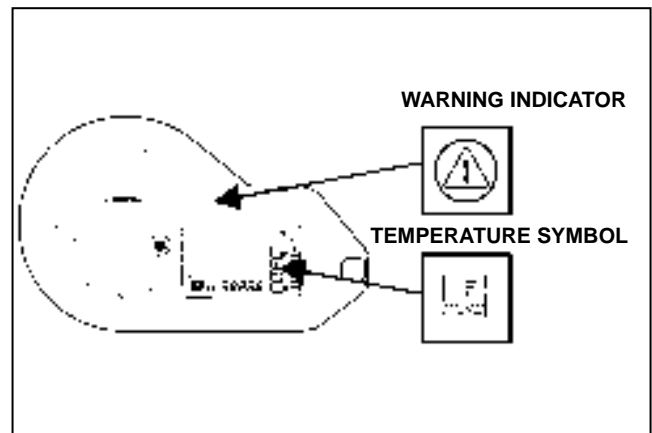
3. Engine is actually overheating (coolant boils over) due to abnormal operation that prevents the standard heat exchangers from getting enough snow splash for optimum cooling efficiency. Examples would be use in marginal (icy/hard-packed surfaces) or poor snow conditions, or operation at extreme low speeds (below 15 mph) for long distance.

- Remedy:**
1. Refer to the flow chart in the service procedure section to diagnose the cooling system problem.
 2. Refer to the flow chart in the service procedure section to diagnose the electrical system problem.
 3. If the unit is primarily operated in marginal conditions or at slow speeds as described above, recommend to the customer that an optional rear heat exchanger be installed to increase cooling efficiency.

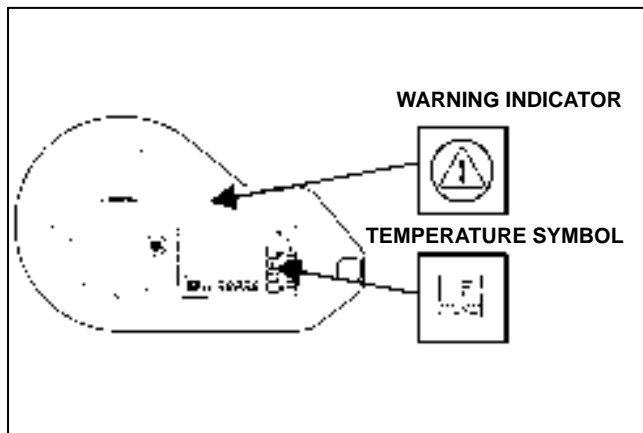
- What were the riding conditions when the overheat warning indicators came on?
- Was there sign of actual overheating (coolant boiling over) or just the warning indicator?
- Were the overheat warning indicators on constantly or flashing? Indicators on constantly usually indicate overheating; indicators which are flashing usually indicate an electrical system problem. For example, a pattern of eight short flashes points to a short or open in the thermosensor circuit.
